Chapter 8

The Grounding of the *Royal Majesty*

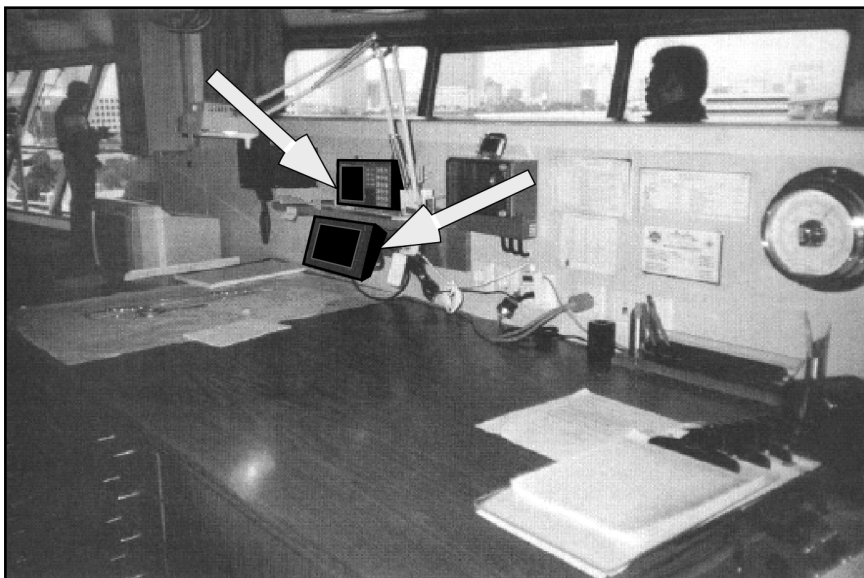
Figure 8.2. The chart table and the bridge. The left arrow points to the GPS unit, the right arrow points to the LORAN-C unit. Source: National Transportation Safety Board (the photo has been enhanced).

waves. The roof above the bridge of a vessel is called the “flying bridge.” Passengers were never allowed to walk on the roof, and the officers hardly ever used it during a passage, but electricians and technicians would climb up there on a fairly routine basis to check the cables and maintain the GPS and LORAN-C antennas. The *Majesty’s* flying bridge was just like any other—a low railing all around, antennas of all sorts, satellite receiving domes, and bundles of connecting wires—except that the gray coaxial cable coming out from the closed bridge and leading to the antenna of the global positioning system was hanging loose; it wasn’t sufficiently secured or strapped to the flying bridge’s roof.

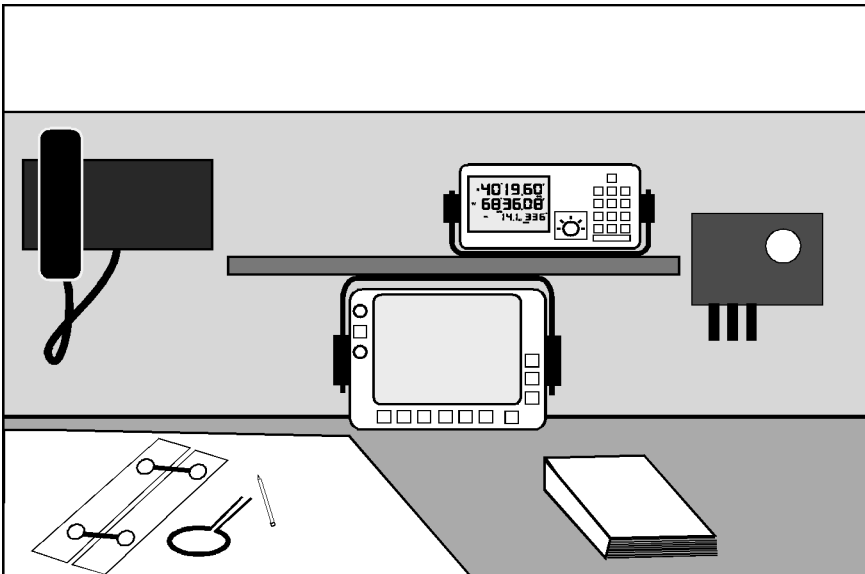
Figure 8.5 (a). The chart table and the GPS unit (top shelf) and LORAN-C unit (bottom of shelf).

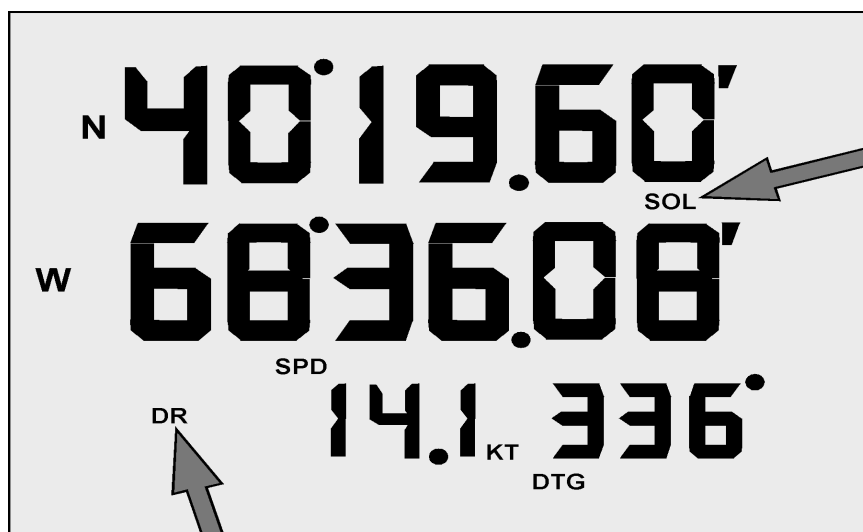
But what neither of them noticed was that in addition to the latitude and longitude coordinates and all the usual data, the GPS display showed two small, innocent-looking text symbols—**SOL** and **DR** (figure 8.5[b]). But these two symbols were hardly innocent—they portrayed a serious problem in the GPS. **SOL** stands for **SOLUTION**, indicating that the GPS was *no longer* computing an accurate position solution. Actually, it had not been producing accurate position solutions for quite some time—ever since the connector between the cable and the GPS antenna had given up an hour after departure, the unit was unable to receive any satellite signals and update its true location.

Figure 8.5 (b). GPS display indications at 8 P.M. on the night of the grounding. The arrows show the DR (dead reckoning) and SOL (solution) indications.

The fact that three officers and the captain did not notice the small **DR** and **SOL** symbols on the GPS display may suggest a breakdown in bridge-keeping practices and poor interface design on behalf of the GPS manufacturer. The symbols were very small (about 1/8 of an inch), inconspicuous, and somewhat misleading (**SOL**). Furthermore, the GPS alarm was not connected to the general alarm system in the bridge, so that when the cable broke and the alarm sounded, only someone who was standing by the unit would hear the one-second beep, which was barely audible to begin with for such a critical failure. Finally, as mentioned earlier, the interface between the GPS unit and the autopilot and radar map was incorrect.

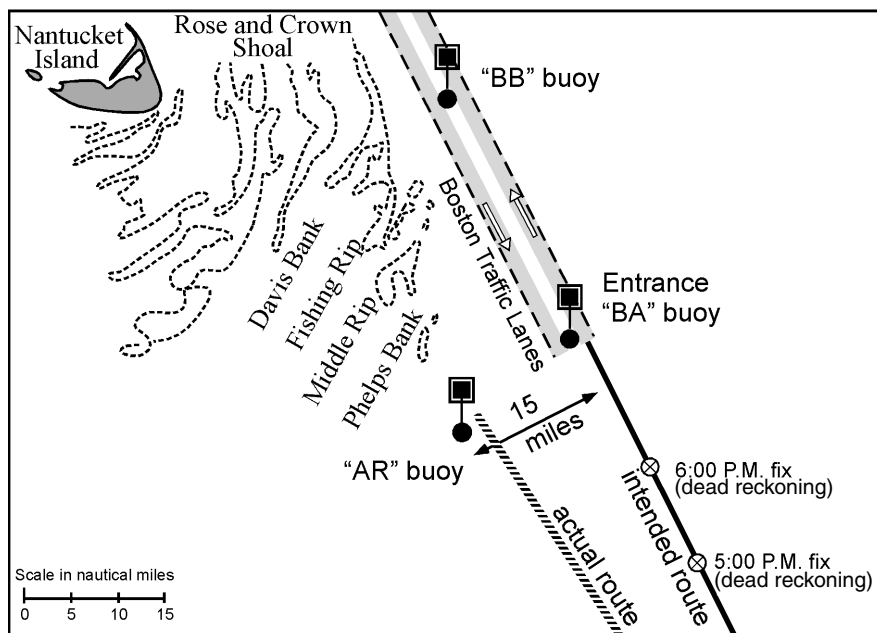
Meanwhile, the crew was plotting the ship's position by reading off the latitude and longitude from the GPS display, assuming the position portrayed there was accurate, as always. And since the GPS unit was spitting out dead reckoning positions—completely oblivious to what the sea and wind were doing to the ship—the trail of hourly plotted fixes on the chart showed as if she was exactly on her intended track. Therefore, nothing appeared amiss—the navigation actually looked perfect. And since the time-honored rule of taking a backup fix (from another source, e.g., LORAN-C, radar, or celestial navigation), was not practiced on the *Royal Majesty*, her officers believed that all was well. But at any rate, at 5 P.M. on June 10, after 28 hours in DEAD RECKONING mode, the *Majesty* was 14 miles southwest of her intended route.

Figure 8.6 (a). Actual and intended route of the *Royal Majesty*.

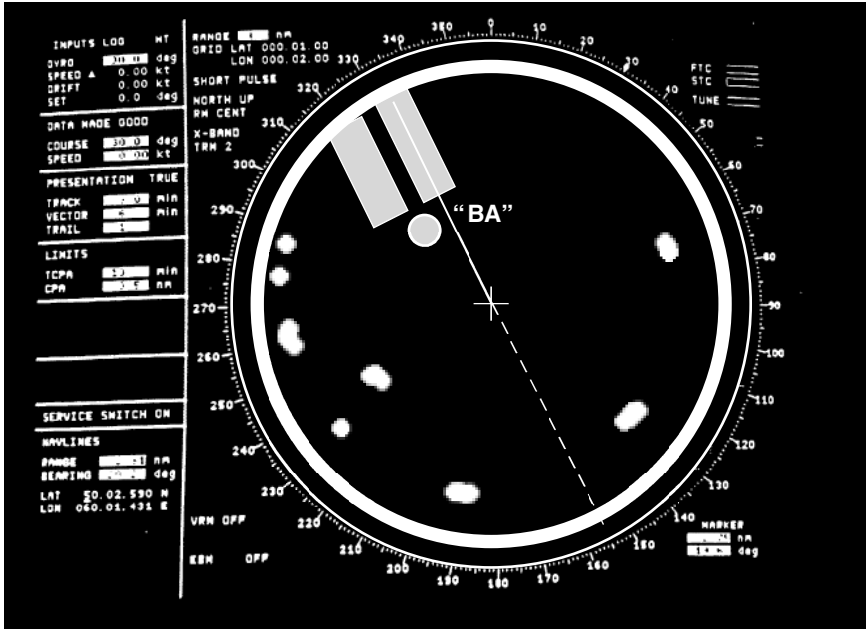
At 6 P.M., the radar map showed the vessel sailing on track and heading accurately toward the right side of the traffic lanes. Yet in reality, the *Royal Majesty* was 14.5 miles west of the lanes, close to shore, and heading toward the dangerous Nantucket Shoals (figure 8.6[a]). The radar map deceived the crew—and the reason for this is important for us to understand because it exposes the kind of problems that plague automatic control systems, especially of the navigational kind. You see, the source of ship position for the radar map display was none other than the crippled GPS unit; whatever the GPS said, the radar map displayed. And since the GPS position did not reflect the ongoing and increasing position deviation, it provided information as if the ship was following its pre-programmed route. That's what the radar map displayed—which was, of course, a false description.

Figure 8.6 (b). The radar map, showing the radar screen and rendering of the traffic lanes and entrance buoy (BA).

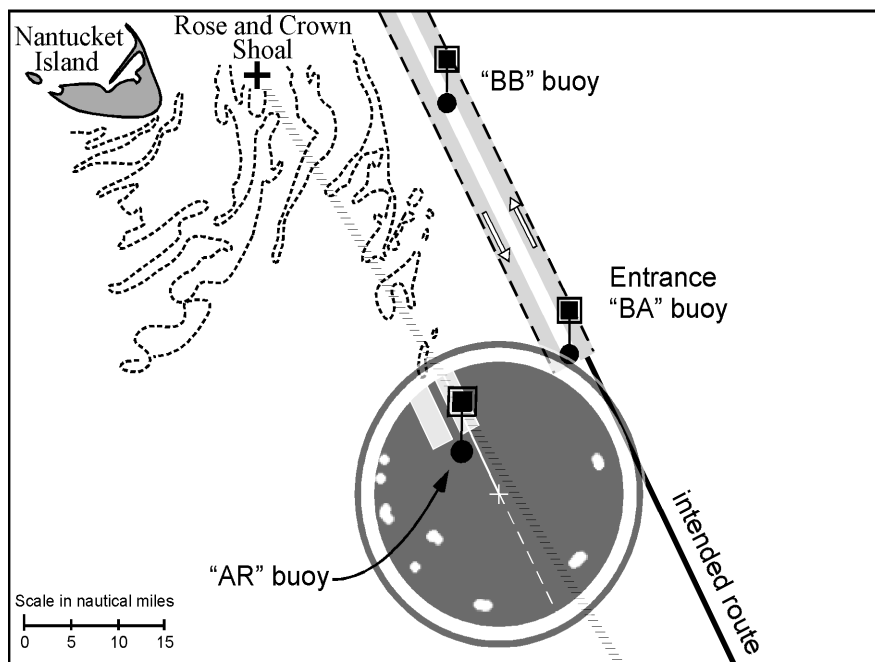
Figure 8.6 (c). Superimposition of the radar map and buoy rendering on top of an actual nautical map. Showing how the actual location of the “AR” buoy matched the expected location of the “BA” (entrance) buoy.

One of them, the Asia Rip buoy, flashing yellow light at a 2.5-second interval, was guarding the southeast tip of the shoal area. Anchored by a long and heavy chain to the wreck of an unfortunate vessel, the Asia Rip buoy was 15 miles to the west of the entrance buoy. And 15 miles is an important number here, because by a rare and unfortunate twist of fate, at that time the *Royal Majesty* was exactly 15 miles off her intended route! And therefore, on the radar map, it was actually the radar return from the Asia Rip buoy that coincided with the rendering of the entrance (BA) buoy (see figure 8.6[c]).
